NOISE INVESTIGATION AND REPAIR OF THE EBR-II INTERMEDIATE HEAT EXCHANGER

H. W. Buschman, B. C. Cerutti,
and A. F. Clark

EBR-II Project

August 1971

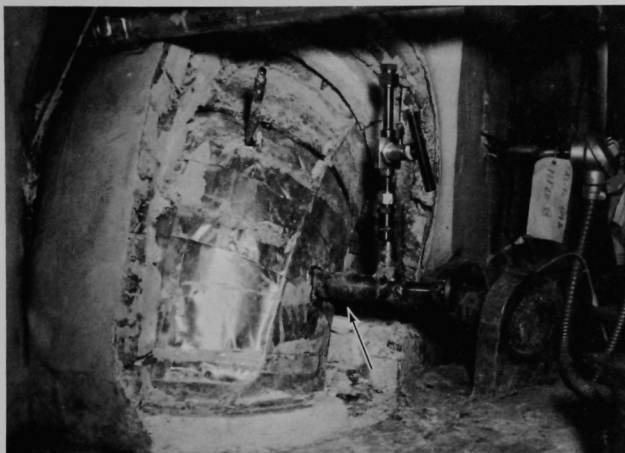
Fig. 7. Evacuation Tube Penetrating IHX Inlet Elbow. ANL Neg. No. 103-N5616.

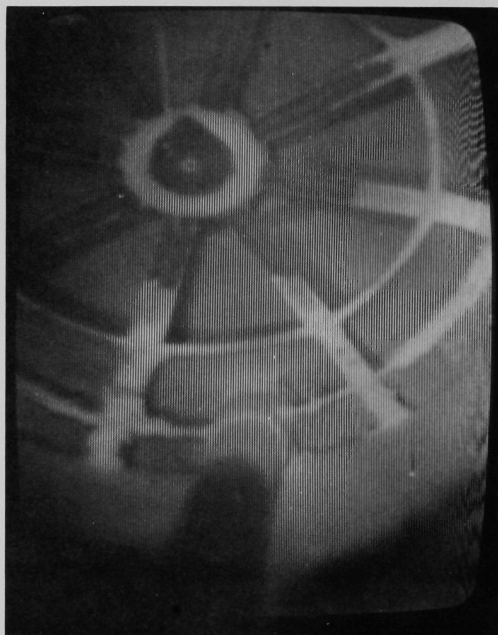
Fig. 15

Television View of Diffuser Troughs and
Support Ribs at Lower End of IHX Inlet
Pipe. ANL Neg. No. 103-05004.

Figure 14 shows the remaining portion of the lower clip, essentially the weld portion. The white spots appear to be sodium deposits. A dark band (not shown) on the tube adjacent to the stub of the lower clip appeared to be the mark left by the lower clip before the clip was broken. Figure 15 is an overall view of the diffuser-trough assembly and support ribs. The lower end of the evacuation tube is also shown in this view. The white areas again appear to be sodium deposits. Figure 16 is a closeup of the terminal piece for the evacuation tube.

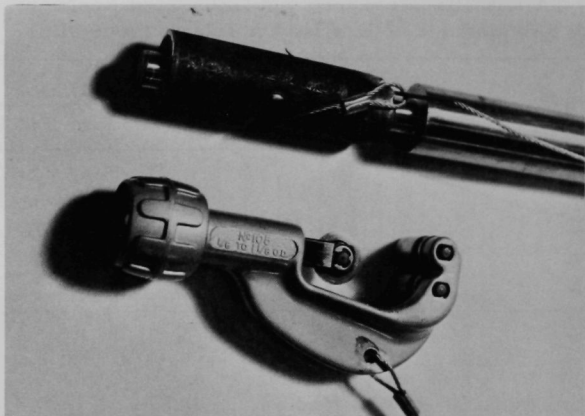
Fig. 20. Removed Upper Piece of Evacuation Tube and
Tubing Cutter. ANL Neg. No. 103-05251.

The evacuation tube was cut off just inside the inlet-pipe elbow. The cut was made with a tungsten-inert-gas (TIG) welding torch. The tools used for this operation are shown in Fig. 19. The end of the tube was then cut again with a tube cutter to leave a smooth end. The end of the tube after being cut off is shown in Fig. 20. Several long thin slivers of molten material were left in the evacuation tube from the TIG cutting operation. These slivers were removed on January 18 with wire brushes. One small sliver was lost in the inlet pipe and not recovered.

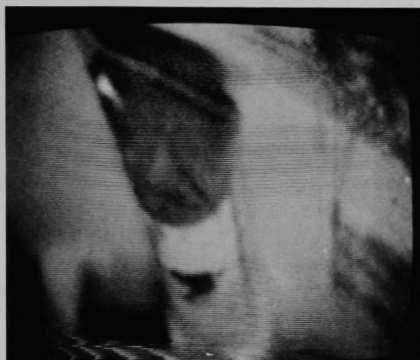
a. Remaining Stub after Removal
of Evacuation Tube

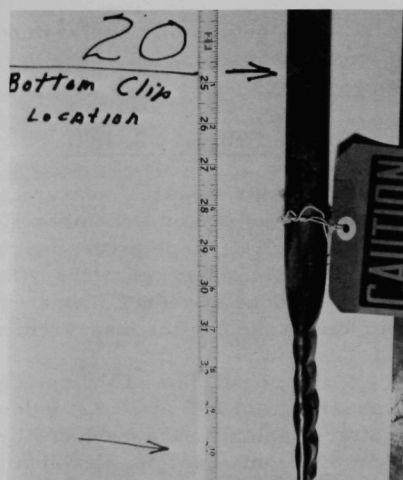
b. Bottom of Removed Tube

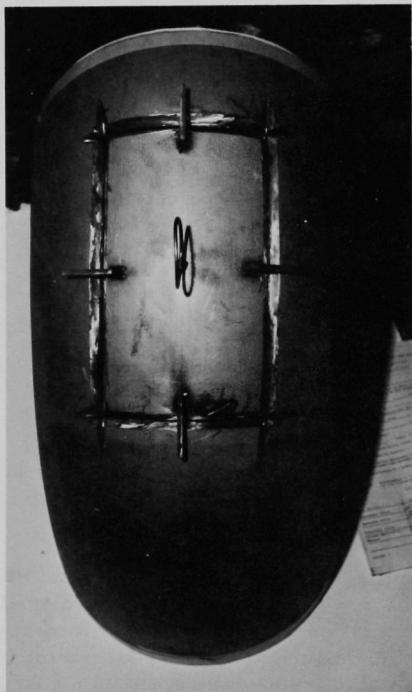
The initial attempt to reweld the patch in the test elbow was not successful. Difficulty was experienced because the removed section was distorted by weld-metal shrinkage.

The positioning clips as shown in Fig. 25 were not strong enough to hold the patch in place. Because of this difficulty, the technique for cutting and rewelding was modified as follows:

Fig. 25. First Elbow-weld Specimen, Showing Lightweight Positioning Clips. ANL Neg. No. 103-N5788.

1. The positioning clips were made stronger, and their number was increased from four to six.

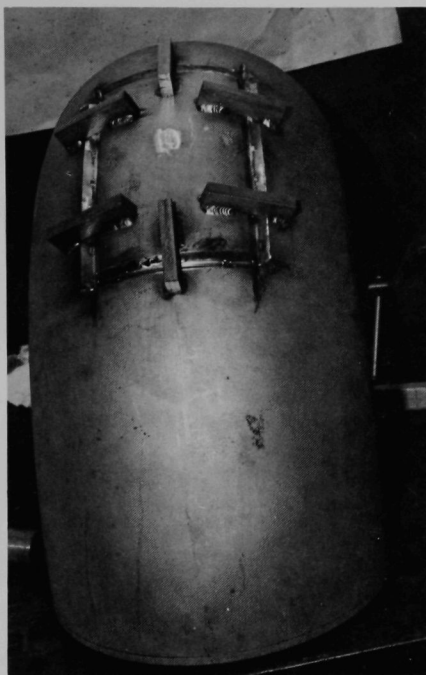
Fig. 26

Modified Elbow-weld Specimen, Showing Consumable Insert and Heavyweight Positioning Clips. ANL Neg. No. 103-N5842.

With the above changes to the cutting and welding procedures, the welding was accomplished on the test elbow without difficulty. Figure 26 shows the test elbow with the positioning clips and consumable insert in place ready for welding of the root pass. The completed weld was radiographed through the opposite wall of the elbow using an iridium-192 source.

The radiograph and also a liquid-penetrant examination of each weld pass verified that the test weld was acceptable. This operation confirmed that it was possible to enter the IHX by the method proposed and later accomplish a satisfactory closure.

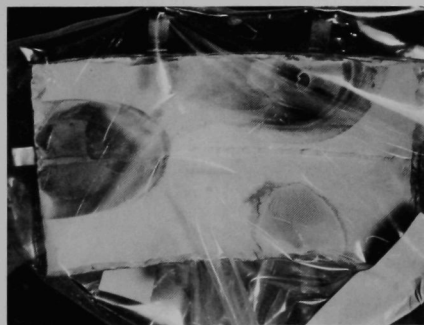
Figure 31 shows the access port installed on the IHX inlet elbow with the cutout section ready for removal. Figure 32 is a sequence of photographs showing (a and b) removal of the cutout section through the access port, (c) the access port with shutter closed, (d) the view through a Plexiglas cover bolted on the access port, and (e and f) the section removed from the elbow. The photograph (Fig. 32e) of the underside of the section shows that the surface was completely wetted by the sodium.

e. Bottom View of Cutout Section

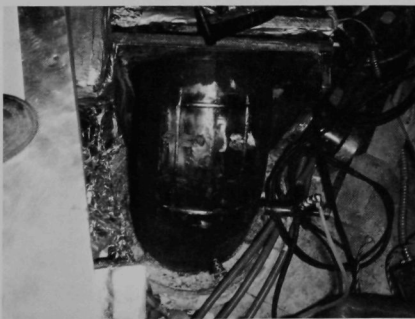
The cleaning, fitting, and welding process on the elbow section is shown in the sequence of photographs of Fig. 33. The root pass of the weld and removal of the support clips was accomplished by the sequenced procedure included in Appendix B. The root pass was examined by radiography, and the following defects were found:

e. Completed Root Pass

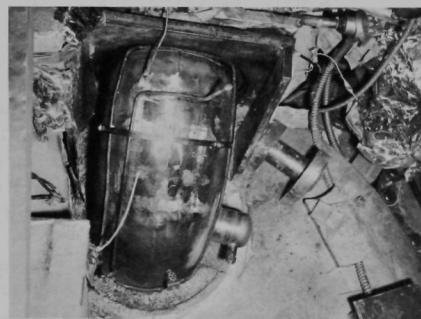
f. Completed Weld of Cutout Section

The stub of the evacuation tube outside the inlet elbow was shortened and cap-welded as shown in Fig. B.2. As the figure shows, secondary containment was provided over the evacuation tube where it penetrated the inlet elbow. Figure 33f shows the inlet elbow with all welding completed and ready for insulation.

Fig. 33. Sequence of Photographs Showing Deburring at Elbow and Welding of Cutout Section.
ANL Neg. Nos. 103-05574, 103-05571, 103-05634, 103-05633, 103-05581, and 103-05639.

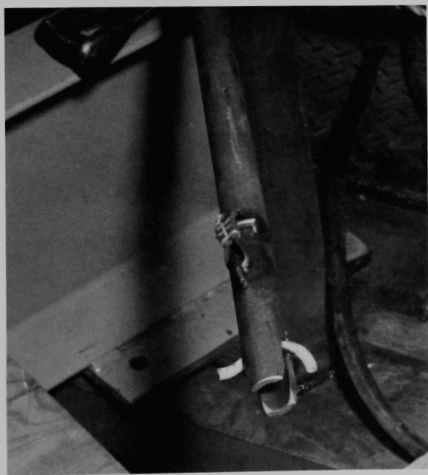
Fig. 51. Twist-off Tool with Removed Upper Clip. ANL Neg. No. 103-05234.

The tools were used without difficulty to remove the upper clip. Figure 51 shows the clip in the breakoff tool immediately after removal from the IHX.

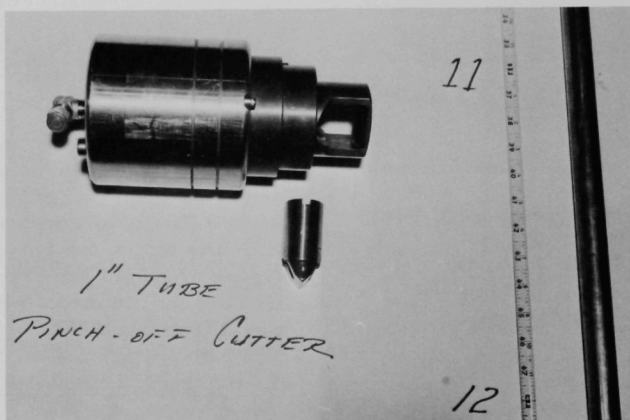
Fig. 52. Pinch-off Cutter for Removing Evacuation Tube. ANL Neg. No. 103-05373.

precluded further lowering of the cutter. Argon pressure of about 200 psig was then applied to flatten the tube but not cut it, so that additional clearance could be obtained to again lower the cutter. This was repeated until the cutter was about 6 in. from the bottom of the tube. At this point, the full bottle pressure (2000 psig) was applied to the cutter piston and the tube was cut cleanly off, leaving a pinched-shut stub. Figure 24b, a photograph of the removed portion of the evacuation tube, shows how the tube was flattened and pinched off.

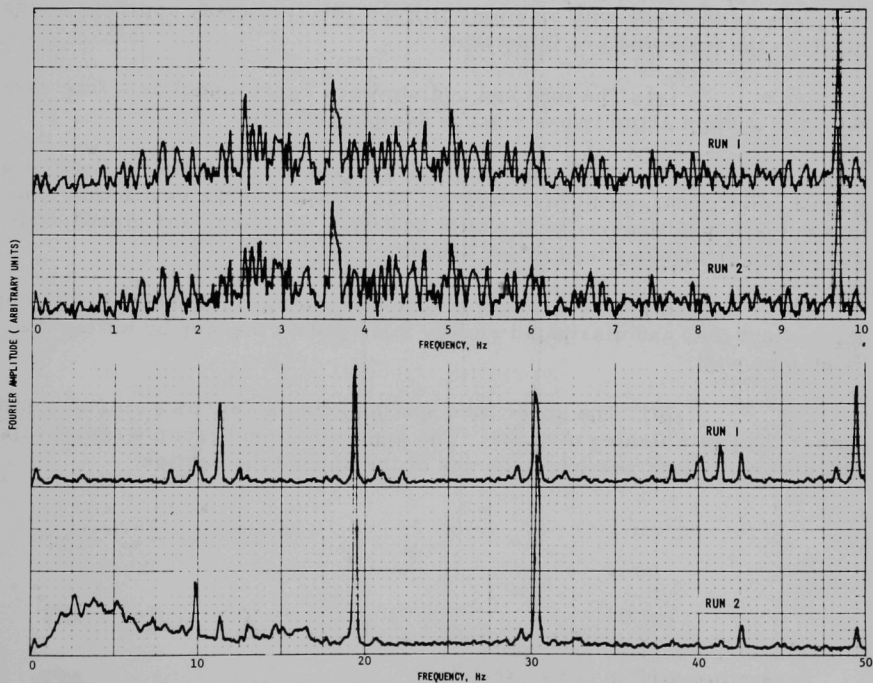
Fig. A.3. Measured Resonant Frequencies of IHX Evacuation-tube Vibration with Both Clips Removed and No Sodium. ANL Neg. No. 103-P5242.

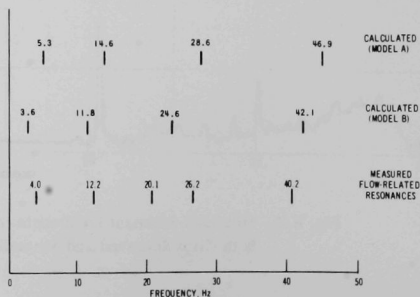
The computed and measured resonances for Case 2 for the lower section ($l = 177.5$) are presented in Fig. A.5. The relative amplitude versus the frequency is shown in Fig. A.6 for data accumulated with the system intact on November 17, 1970. Each data plot was taken for various indicated flows of the secondary sodium. (The primary sodium flow was constant.) The measured frequencies shown in Fig. A.5 result from examining

Comparison of Calculated and Measured Resonant Frequencies for Case 2. ANL Neg. No. 103-P5241.

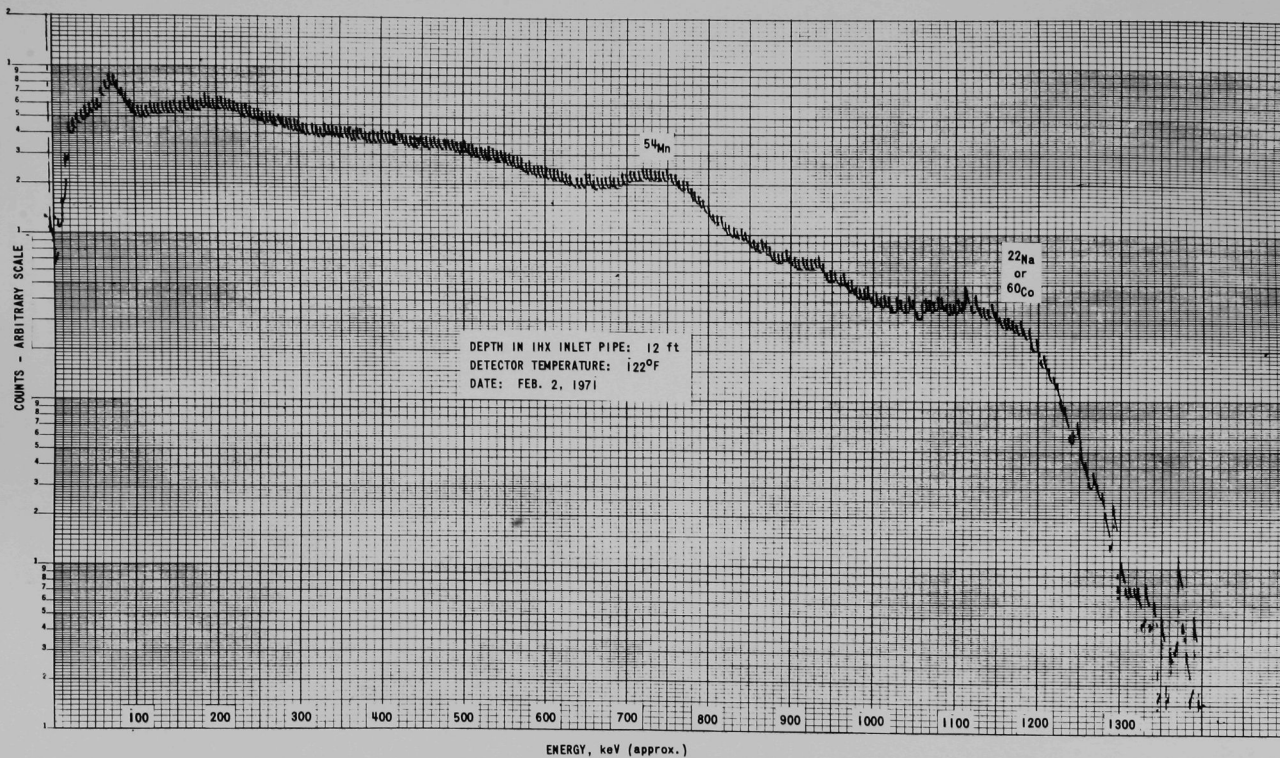
Fig. C.1. Gamma-ray Energy Spectrum of IHX

This record indicates a broad peak in the range of 800-850 keV. The shift of the apparent energy location of this peak (to 700-750 keV) with increase in detector temperature (72-122°F) was similar to the shift observed with a ¹³⁷Cs calibration source. A record was taken using the ¹³⁷Cs source before and after this examination.

The gamma ray with the highest probability of occurring in the energy range of 800-850 keV is ^{54}Mn (840 keV, half-life 314 days). The falloff of the gamma-ray spectrum occurs at about 1.30 MeV, which coincides with the ^{60}Co (1.33-MeV) and the ^{22}Na (1.28-MeV) gamma-ray energies. Since the detector was below the upper level of the primary sodium, ^{22}Na is the most likely origin of the higher-energy gamma-ray spectrum.
